**James Collie  
c/o Northco Group of Co.**

**Hydrogeological (Septic) Study  
Proposed Seniors' Housing Development  
Southwest of Highway 130 and Arthur Street West Intersection  
Oliver Paipoonge, Ontario**

**Project Number**  
THB-23005042-A0

**Prepared By:**  
EXP Services Inc.  
1142 Roland Street  
Thunder Bay, ON P7B 5M4  
Canada

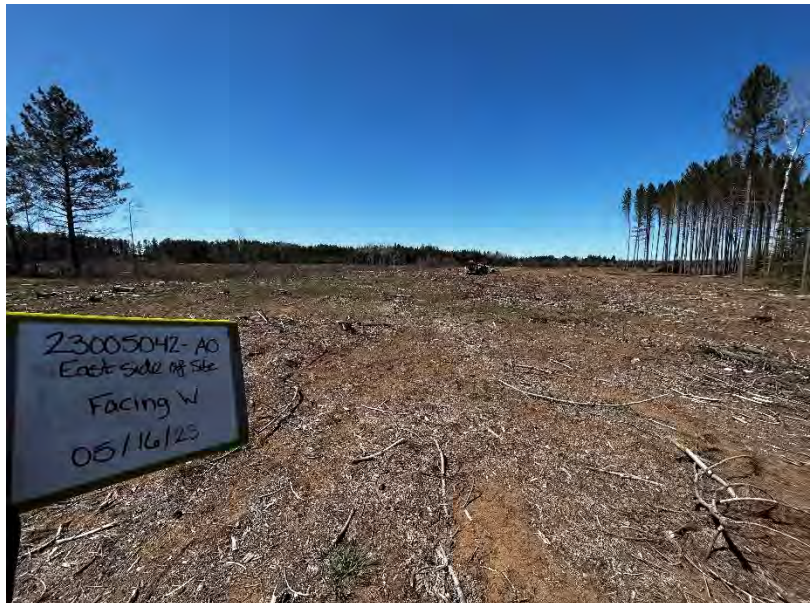
Looking west across the site from the northeast corner of the site. The intermittent ditch is located in the centre and extends to the left (brush from within the ditch is visible).

At the time of the field investigations, the site was undeveloped with the exception of a roadway at the northeast part of the site (access via Highway 130) and was generally tree cleared. An intermittent ditch was observed at the northwest part of the site and presumably flows (ditch was dry at the time of the fieldwork) southeast to near the east site limit, adjacent to a residential property, and then generally flows south to Pennock Creek, which is located near the south site limit; refer to Figure 2 in Appendix B. The site topography appears to be generally flat with the exception of the intermittent ditch, previously discussed. Of note, near the south site limit and at the potential Future Green Space area, the site topography slopes down towards Pennock Creek.

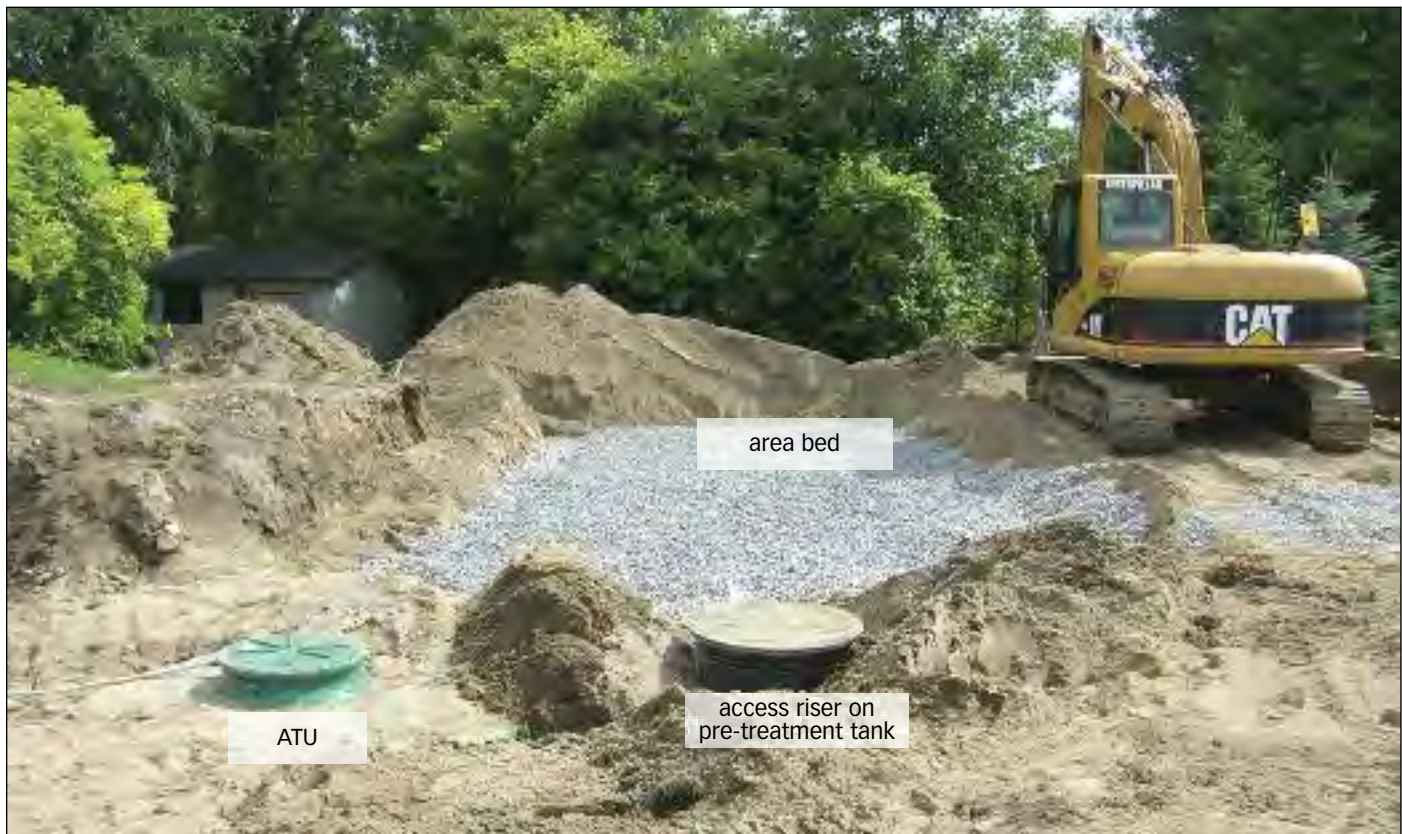
ATUs receive wastewater from household plumbing fixtures (toilets, showers, sinks, etc). These units often have a pre-treatment tank where the scum and solids are separated and stored before the effluent is passed to an aeration chamber. At the aeration chamber, air is added to the effluent, which allows the bacteria to feed on the contaminants thereby producing cleaner effluent.

Generally, ATUs are classified based on the status of bacteria in the wastewater within the treatment unit. Bacteria are either suspended in the liquid or attached to some media.

ATUs used in conjunction with an area bed or shallow buried trench are well-suited for replacement systems on mature, landscaped lots with limited space.

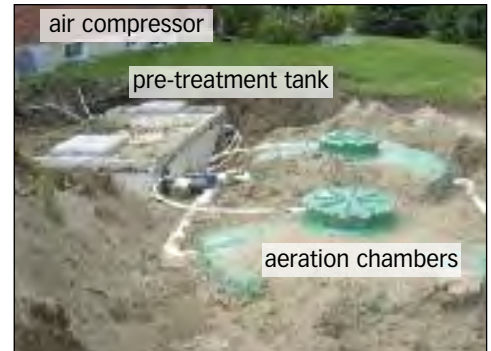
In **suspended growth treatment units**, wastewater flows from the pre-treatment tank into the aeration chamber where an air compressor and air diffuser supply oxygen and mix the liquid waste. The air keeps the bacteria “suspended” or floating in the liquid waste. It does not attach to any surface. The oxygen supports the growth of the bacteria and other micro-organisms that break down the wastewater and solids. The effluent then flows into a shallow buried trench or area bed.

Large sewage design flows may require more than one aeration chamber.

Effluent treated by a suspended growth unit can be distributed back into the native soil through a shallow buried trench or an area bed.

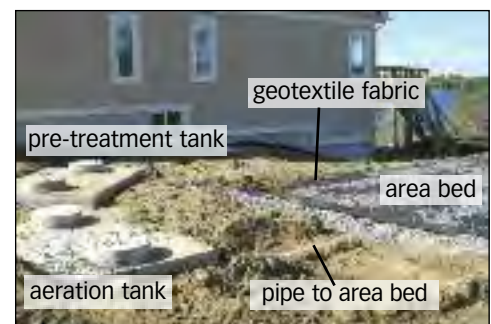
In **attached growth treatment units**, wastewater from the pre-treatment tank flows into an aeration tank that contains pieces of plastic or other synthetic material. Attached growth units rely on oxygen-dependent bacteria to break down wastewater and solids similar to suspended growth units. The difference is that attached growth units let the bacteria attach, grow and thrive on the synthetic material (e.g., plastic shavings, balls, etc.). An air diffuser provides continuous aeration around the synthetic material to enhance bacterial activity and waste treatment. Some attached growth treatment units require an air compressor. The effluent then flows to a shallow buried trench or area bed.

Pre-treatment tank followed by an aeration tank and area bed.

Effluent treated by an attached growth unit can be dispersed back into the native soil through a shallow buried trench or an area bed.

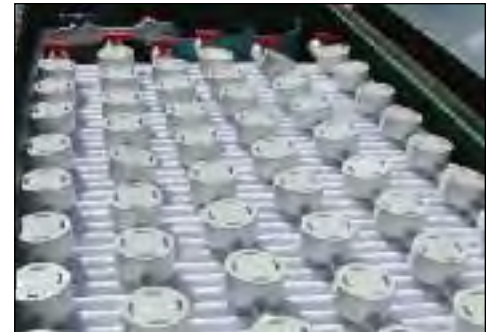
Synthetic media — geotextile sheets.

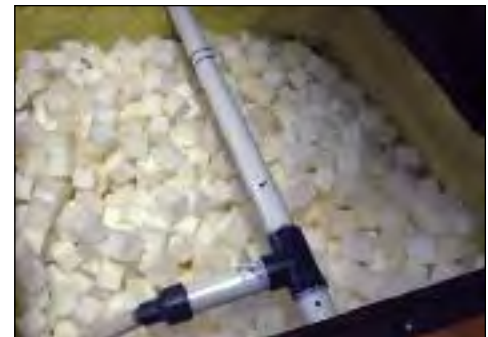
Synthetic media — foam cubes (top view).

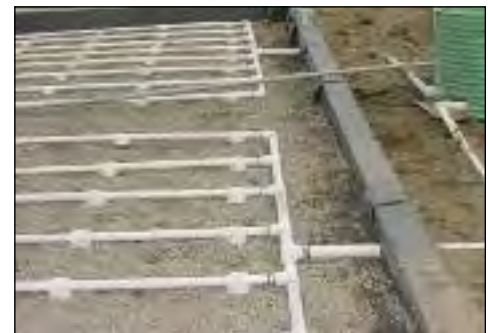
Sand filter.

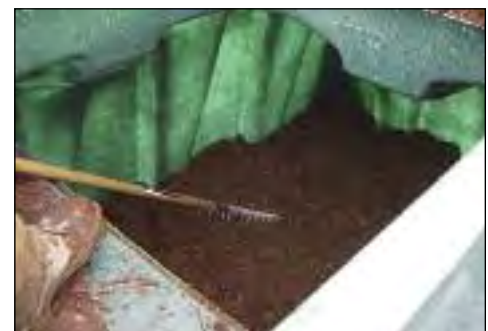
Peat moss.

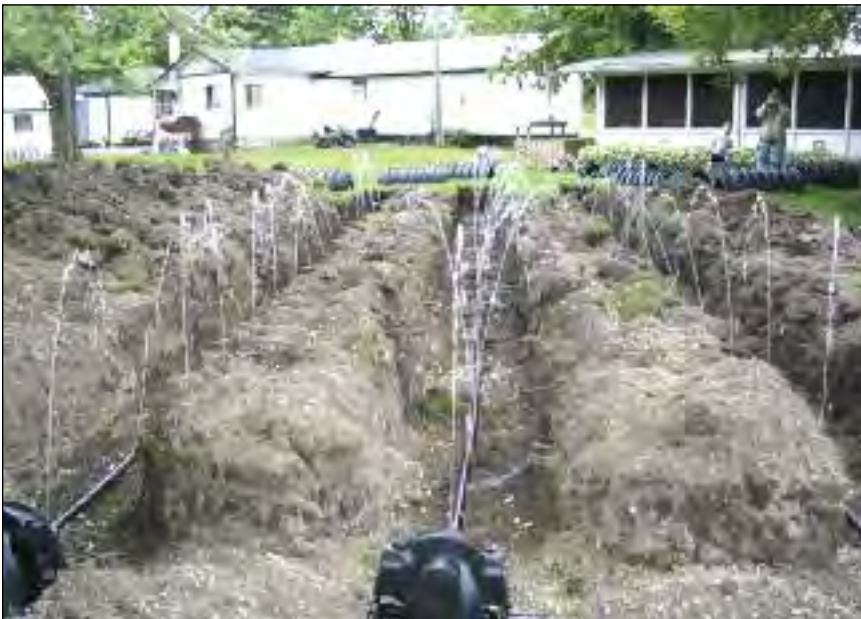
Trenches can be installed as one row or several rows to meet minimum trench length standards as required by the *Ontario Building Code*. This method is versatile because the trench can follow an irregular pattern (e.g., around trees).

Shallow buried trenches showing equal distribution methods. Note: before placement of chambers.

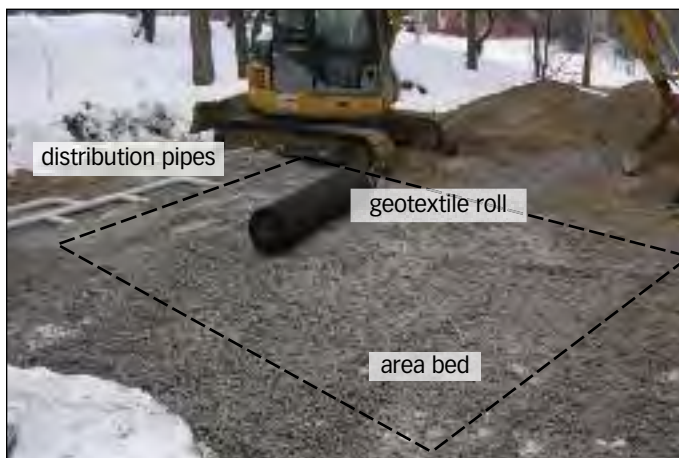
An area bed showing stone layer, pipes and geotextile fabric.

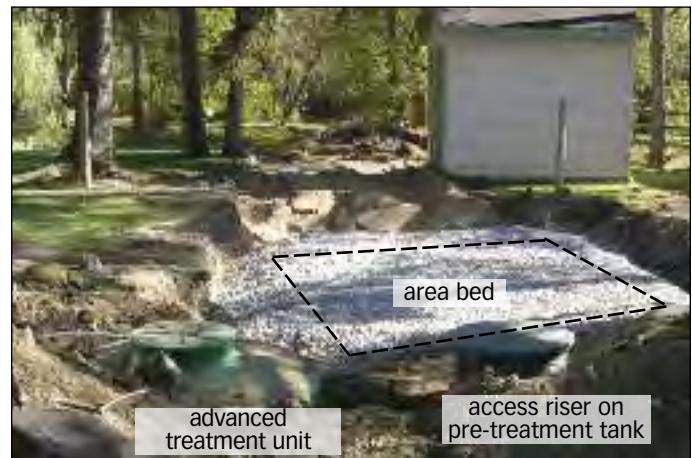
An area bed in a small space.

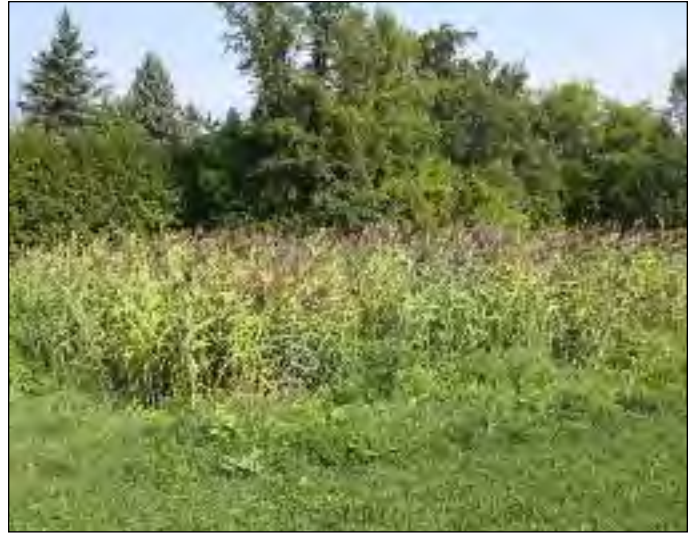
Subsurface constructed wetland.

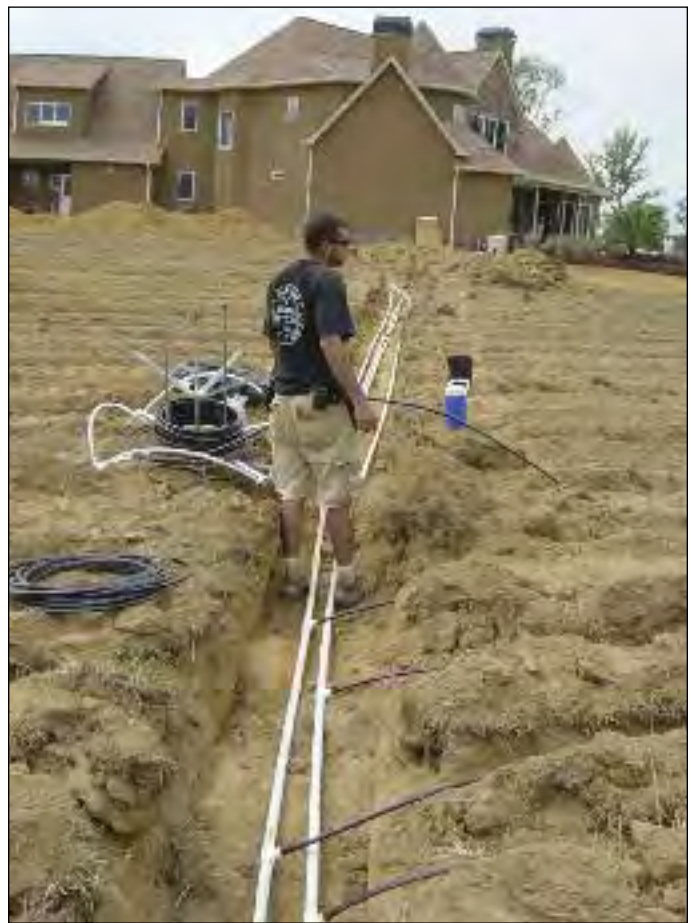
Drip dispersal system.

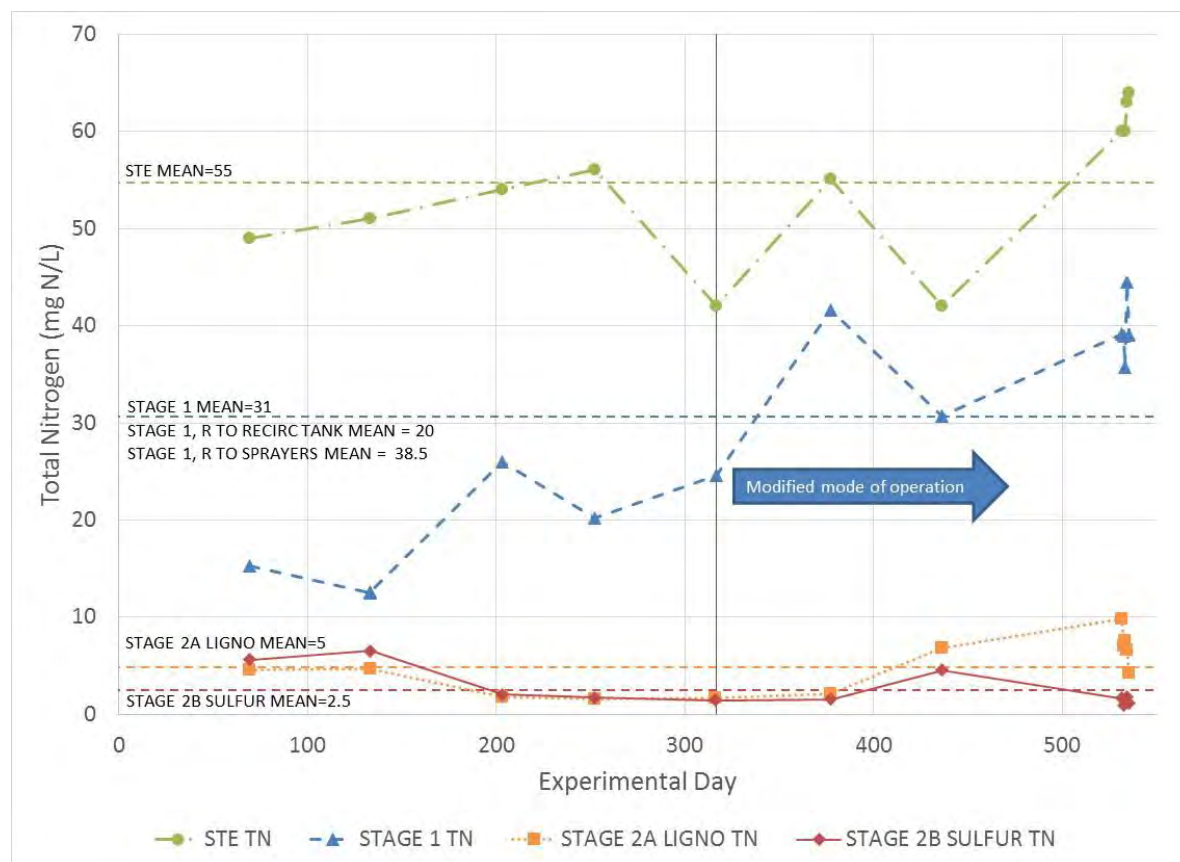
Fig. 3. Time Series of Nitrogen Data for the Hillsborough PNRS.

More importantly, Figure 3 illustrates that higher average TN reduction occurred in the Stage 1 biofilter when recirculation of nitrified effluent went to the recirculation tank as compared to recirculation to the Stage 1 biofilter sprayers. The treatment system total nitrogen reduction for the two modes was similar, but operational mode two (recirculation to sprayers) shifted more of the nitrogen removal to the second stage biofilter. For long-term operation, increased nitrogen reduction within Stage 1 using a recirculation tank may be beneficial in that less of the reactive media is required for treatment downstream within the Stage 2 biofilter, resulting in longer life of the stage 2 media before replenishment. However, the second mode of operation also produced excellent treatment results and could eliminate the recirculation tank from the system design.

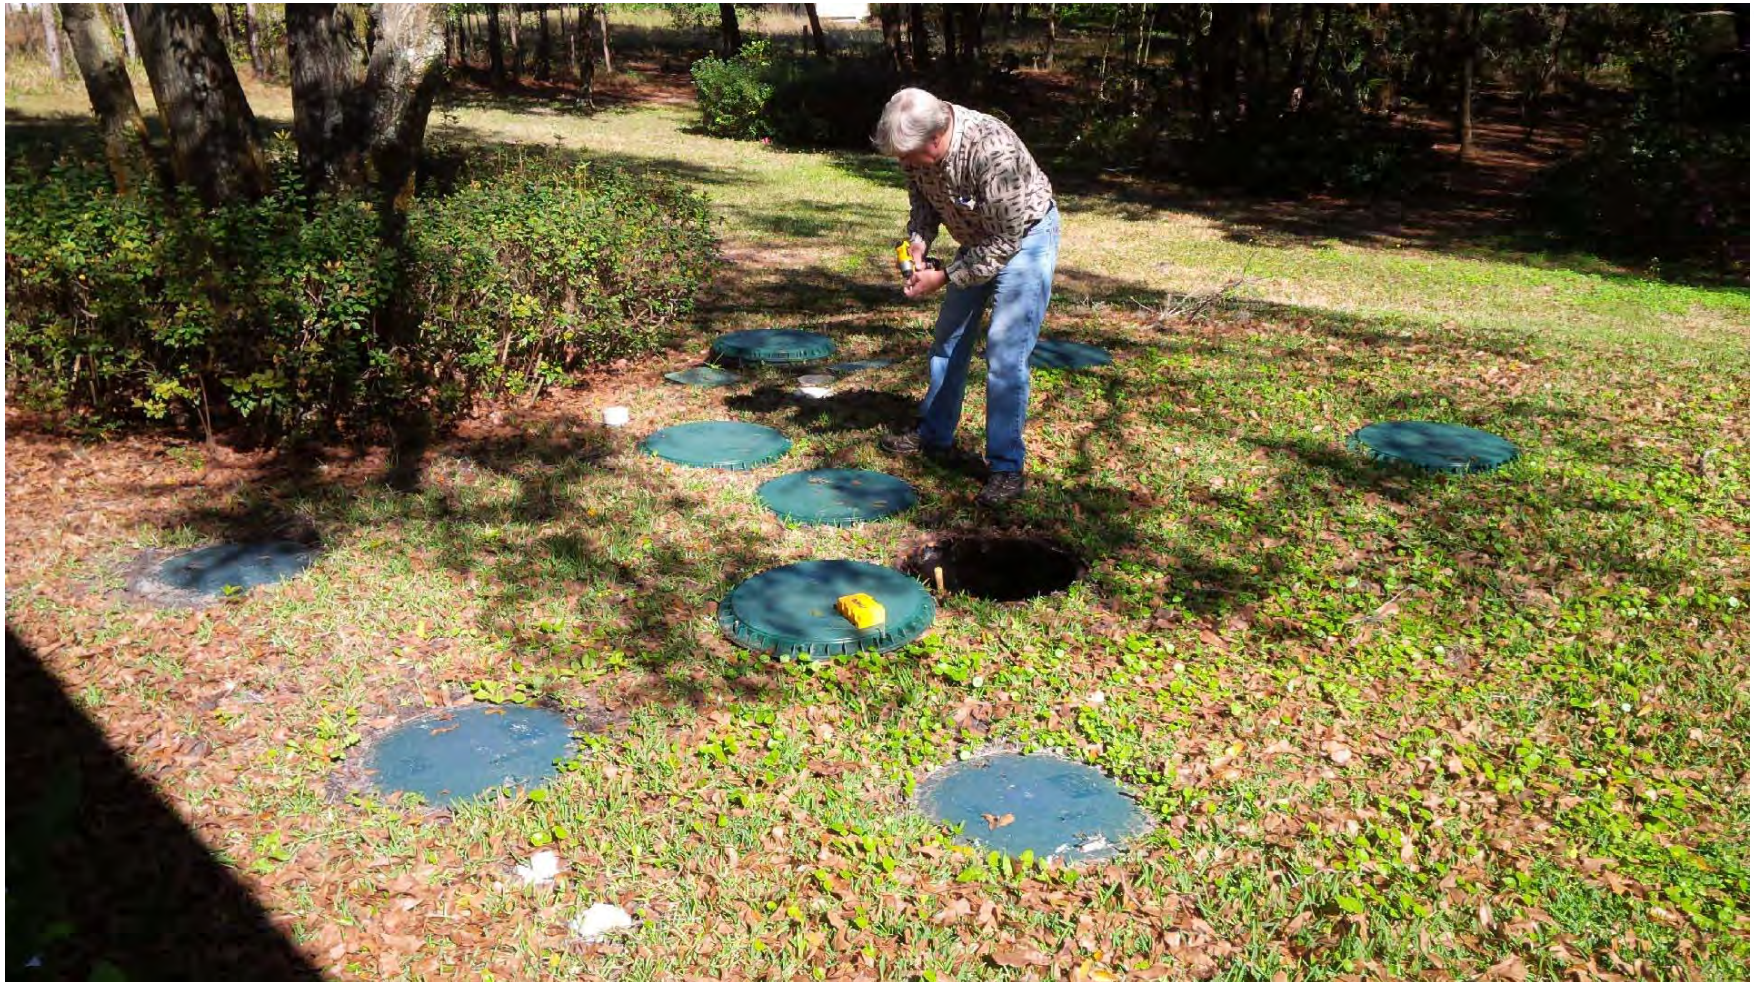
Hillsborough Denitrification Site, Tampa FL  
Damann Anderson January 2015

- Nitrate plume in groundwater below septic system is removed entirely after in-ground LS-type system installed in Florida;  
Anderson and Hirst 2015

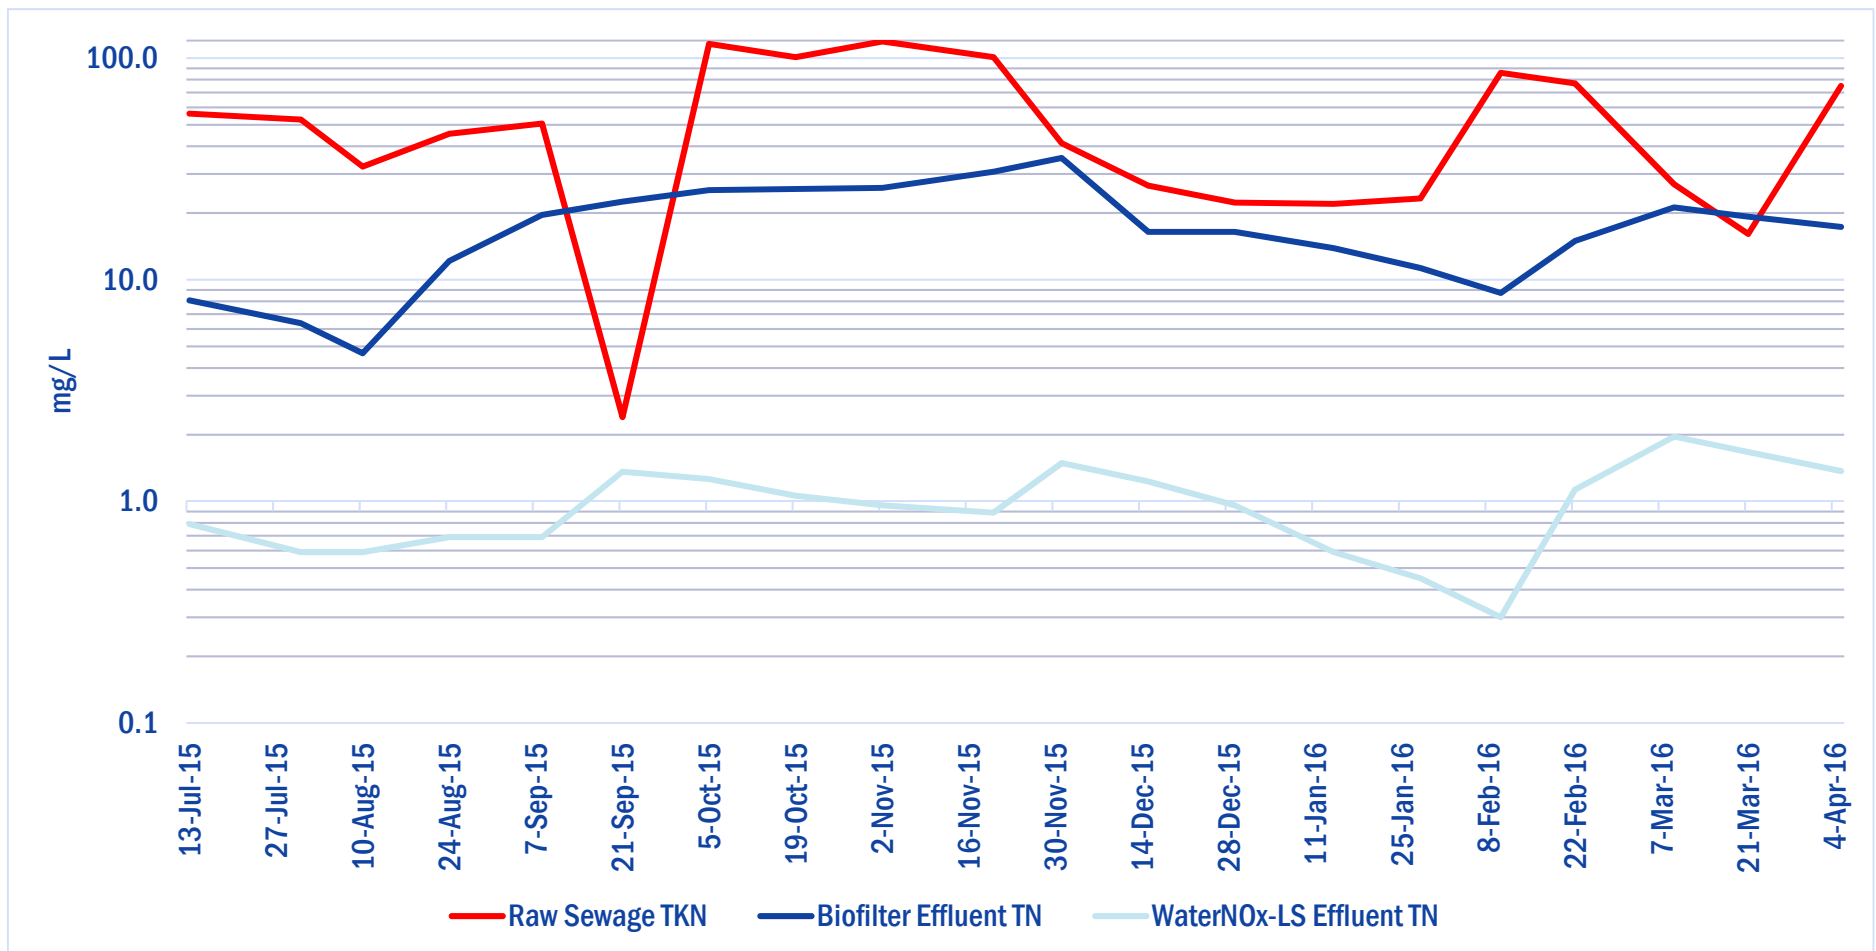
# WaterNOx-LS

- Biofilter TN % Removal = 72%
- WaterNOx-LS TN % Removal = 95%
- Total TN % Removal = 98%
